Executive Summary

HITECH Rotary UPS

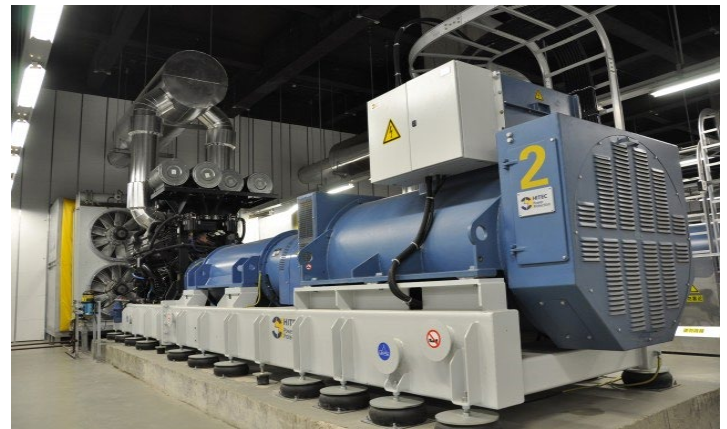
Our customer operates a large, high-reliability facility requiring a continuous supply of electrical power. A HITEC Rotary UPS has been commissioned to enhance overall power reliability. The UPS is a highly sophisticated and physically large machine that requires detailed end-to-end alignment and careful operating observation.

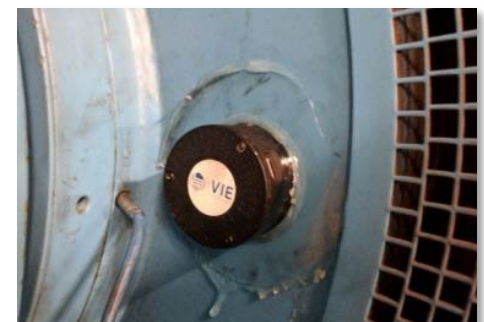
OPA sensor installation

On site, two MyVIE sensors were epoxied to the UPS, one on either side of the induction coupling, near the bearing plates. While additional sensors may be added to other parts of the UPS in the future, these two allowed us to focus on the question of reliability of the induction coupling. A MyVIE wireless gateway was installed approximately 100 feet from the UPS and provided cloud connectivity for the MyVIE sensors. MyVIE was initialized and over the first few days, collected both high and low resolution baseline readings.

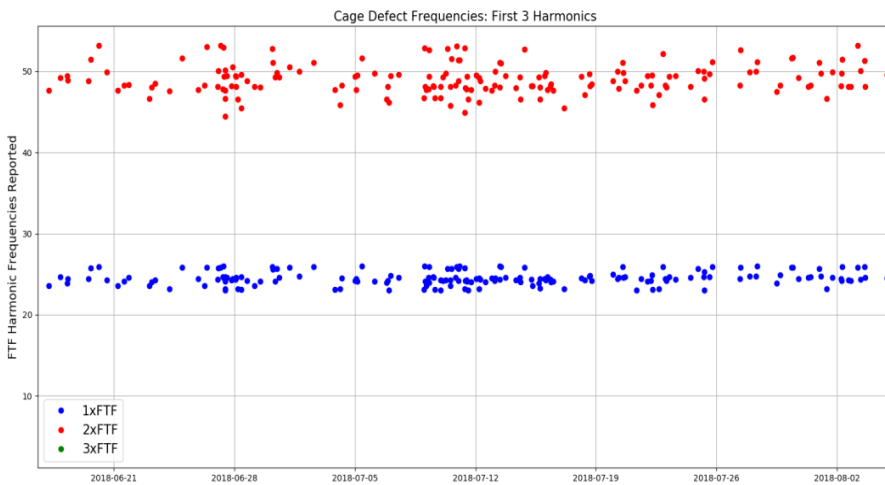
Following the baseline period, MyVIE revealed a number of key operating characteristics of the UPS. Firstly, vibration contributed by the inner rotor (5200 RPM) was more pronounced than by the outer rotor (1800 RPM). Secondly, both inner and outer rotors on the generator side showed high 2x axial vibrations. Finally, a relatively small but pronounced cage defect frequency (inner bearing) was detected.

From combination of these MyVIE analysis results, MyVIE concluded that the inner rotor was slightly misaligned relative to the inner bearing. This misalignment was creating an axial force whose load zone was reflected as cage defect frequency.

On MyVIE's management app, a yellow alert was signaled to the operator on asset PS3A indicating possible imbalance/misalignment. A service ticket #7252 was opened and assigned to a maintenance tech. Based on a visual inspection and review of our data logs, the issue was deemed to be within normal operating windows. This information was logged back into the MyVIE management app.

Key to the power of MyVIE – this feedback was then integrated into the MyVIE intelligence engine and “taught” MyVIE to understand this set of characteristics as normal.

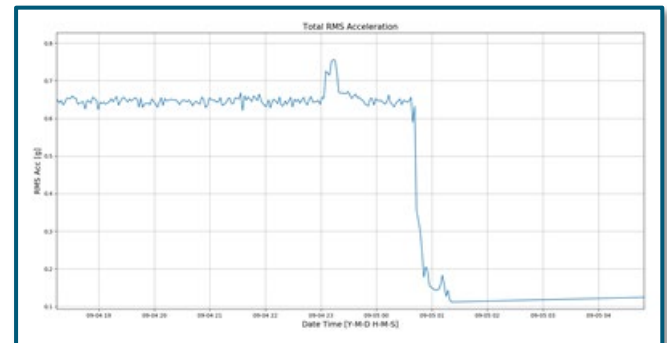
During operation over a weekend, MyVIE detected a UPS system outage, both preceded and followed by large vibration spikes. The outage immediately triggered an alert on the MyVIE app.

The app determined the outage to be 3.5 hours long and further established that vibration related metrics quickly returned to their normal operating range.
